## Heat transfer restored, corrosion inhibited in shell and tube exchanger

CASE STUDY

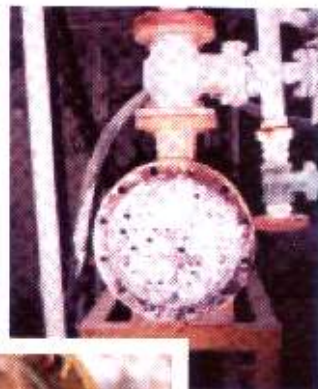
The above photograph shows the success of the *HydroFLOW* C120 unit:

- The heat exchanger lids and tubes were completely clear of limescale deposits.

Initial stages of the deposit of an oxidising film (Gamma Ferric Oxide) were noted on the metal. This film tends to inhibit corrosion.
